Demonstration of Embedded Sensors in Ceramic Structures

Reactor and Nuclear Systems Division

Milestone #: M3TC-20OR0404017

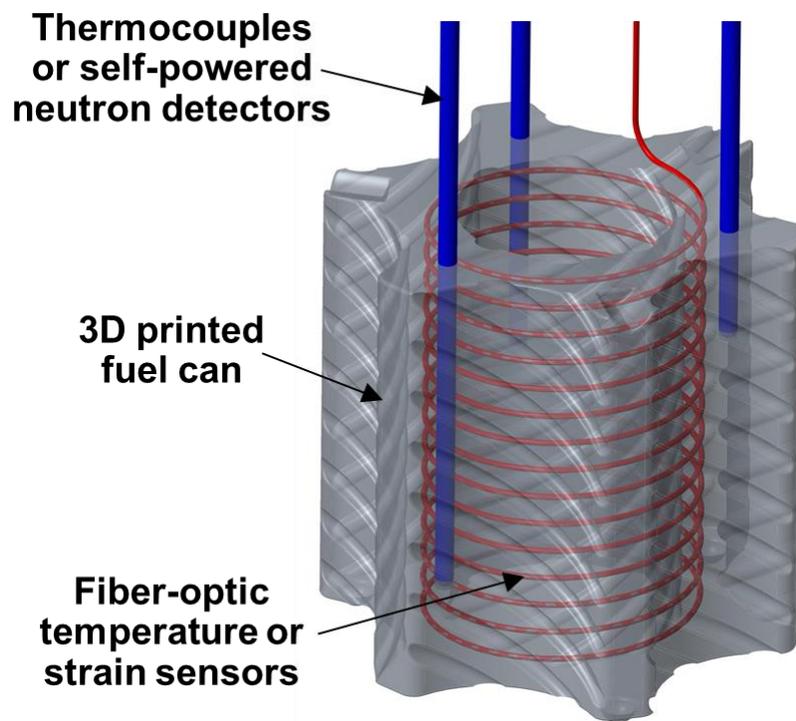
Figure 1. Conceptual illustration of a complex SiC core component with embedded sensors for real-time monitoring of temperature, strain, and neutron flux.

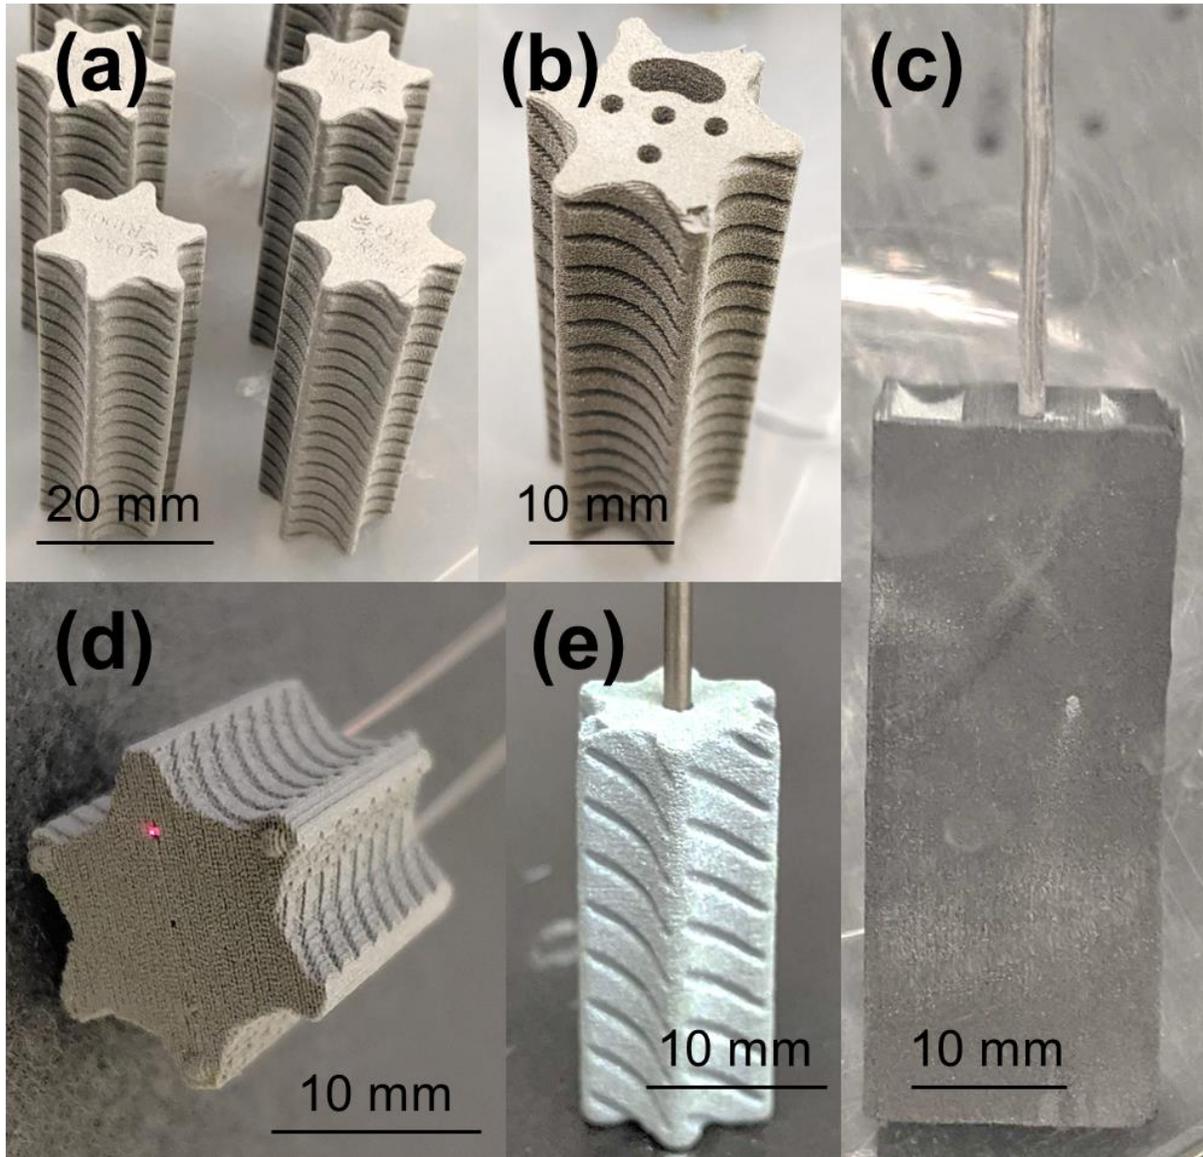
Figure 2. Photographs of complex binder jet parts for embedding sensors (a, b). Methods for incorporating sensors during or after binder jet printing, include surrounding the sensor with loose SiC powder (c), placing the sensor in the binder jet printing bed after pausing the printing process (d), and pressing the sensor into a tight-fitting cavity after binder jet printing (e).

The geometric complexity offered by the SiC 3D printing process allows custom channels to be created for inserting sensors at critical locations before CVI. Figure 2 shows a conceptual example of how a complex SiC ceramic part could be instrumented with sensors. Figure 2(a) and Figure 2 (b) show examples of complex binder jet printed parts for sensor embedding, and Figure 2(c)–(e) show different ways that sensors can be inserted into the part before CVI. The simplest way to insert sensors into a binder jet printed part, as shown in Figure 2(c), is to incorporate an oversized cavity in the component geometry, insert the sensor into the cavity after printing, and then fill the cavity with loose SiC powder.

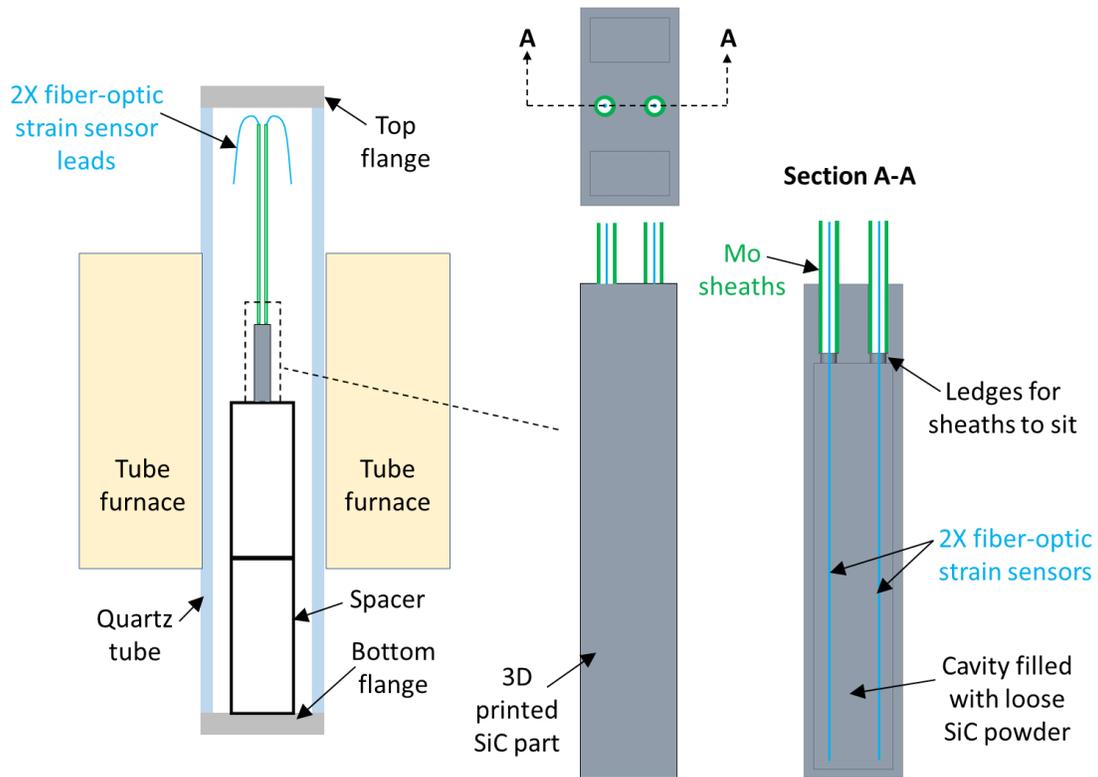
Figure 3. Configuration during the uninstrumented embedding of functional sensors during CVI.

The fibers were not actively interrogated during this first test. Instead, the fibers exited their Mo sheaths inside the CVI chamber with lengths of fiber on the order of ~10 cm extending from the end of the Mo sheaths. The experimental setup is shown in Figure 3. The purpose of this test was to determine whether the fibers could survive the embedding process without breaking and whether any modifications to the SiC component or strain relief would be required before making measurements in situ during CVI. The hope was that lead fibers could be spliced to the ends of the embedded fibers after CVI to measure light transmission through the embedded fibers. The sheaths were designed to rest on a thin ledge that was built into the 3D printed SiC component geometry.

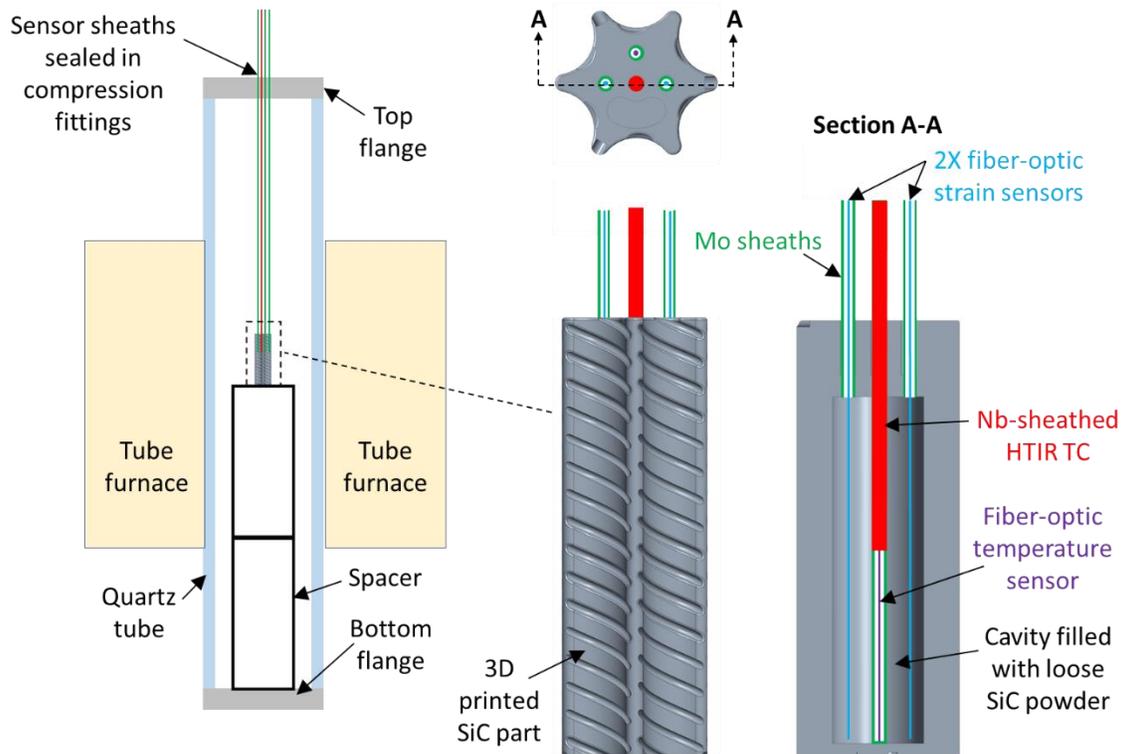
Figure 4. Configuration of embedded sensors within the CVI furnace during instrumented embedding test.

The second experiment with functional sensors involved in situ measurements of sensor performance during CVI. The experimental setup is summarized in Figure 4, and photographs of the assembly are shown in Figure 5. This experiment included a $\Phi 1.6$ mm Nb-sheathed Mo-Nb thermocouple or high-temperature irradiation resistant thermocouple (HTIR TC) developed at Idaho National Laboratory [8, 26]. The same Mo-sheathed singlemode fiber-optic sensors—one coated in Ormocer and the other coated in acrylate—that were included in the uninstrumented embedding experiment were also included in the instrumented test in an attempt to directly embed the fibers in the SiC matrix to measure strain in situ. A third SMF-28 fiber was included inside a closed-ended Mo sheath so that the sheath would be embedded in the SiC part but the fiber would be loosely contained inside the sheath. This allows spatially distributed temperature measurements to be made during CVI. All fiber-optic sensors were sealed with epoxy inside their respective sheaths above the top flange of the quartz tube.

The lessons learned from the uninstrumented test were incorporated into the design of the instrumented test (Figure 4) in which the sensors were interrogated in situ during CVI. The ledges used to support the sensor sheaths were removed, and the vertical positioning of the sensor sheaths was instead controlled by securing the sensor sheaths inside compression fittings in the flange of the quartz tube. The holes in the SiC component were also made larger to prevent the need to thin the sheath walls due to issues with sheath insertion. The plan for the instrumented test was to heat the CVI furnace to a target temperature of 1,000°C in Ar and then start to flow MTS and H₂ to densify the assembly over ~4 days. The furnace was successfully heated to 1,000°C in Ar, but a temporary drop in building air circulation triggered an unexpected shutdown over a weekend. The furnace heating was restarted the following Monday, and the flow of MTS and H₂ was initiated a few hours later. The assembly was infiltrated for approximately 22 hours until another building issue caused a temporary power outage that caused the furnace to shut down again. However, this issue was diagnosed quickly; within <2.5 hours, the furnace was returned to temperature, and MTS and H₂ flow was resumed. The assembly was then densified for another 68 hours without issue. The CVI run was terminated after ~90 hours of densification and allowed to cool to room temperature over a weekend. The following Monday, the furnace was heated to 600°C in Ar to determine whether the sensor response changed before and after embedding.

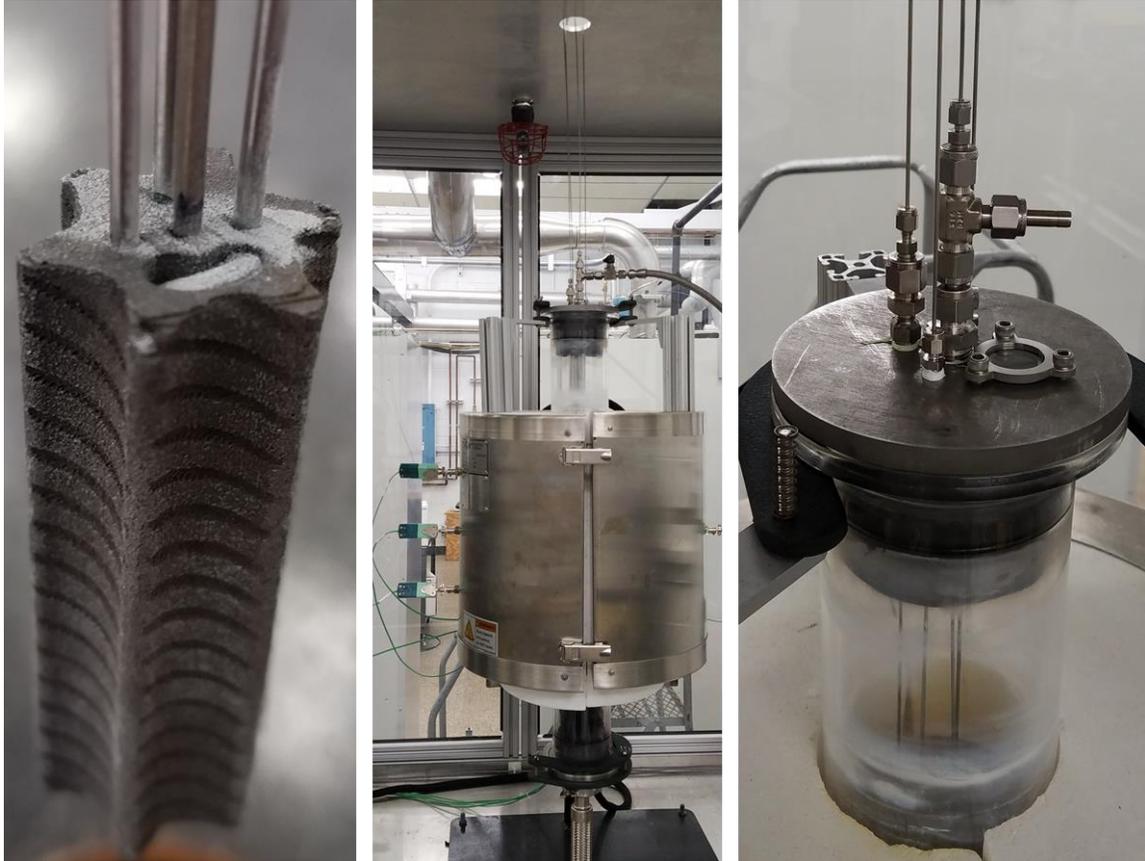
Figure 5. Photographs from the instrumented sensor embedding experiment that show the 3D printed SiC component with assembled sensors and loose powder (left), the CVI system during operation (middle), and the sensor leads secured within the flange at the top of the quartz tube (right).

The 3D printed SiC component in which the sensors were to be embedded was loaded on top of a graphite spacer that placed the component at the centerline of the furnace. The HTIR TC was located at the axial center of the SiC component. The two fiber-optic strain sensors passed to the bottom of the component, but their sheaths only penetrated a few millimeters into the top of the component. The fiber-optic temperature sensor passed to the bottom of the SiC component inside its Mo sheath. The sensor locations were set by measuring appropriate distances from the top flange of the quartz tube and securing the sensor sheaths inside the compression fittings.

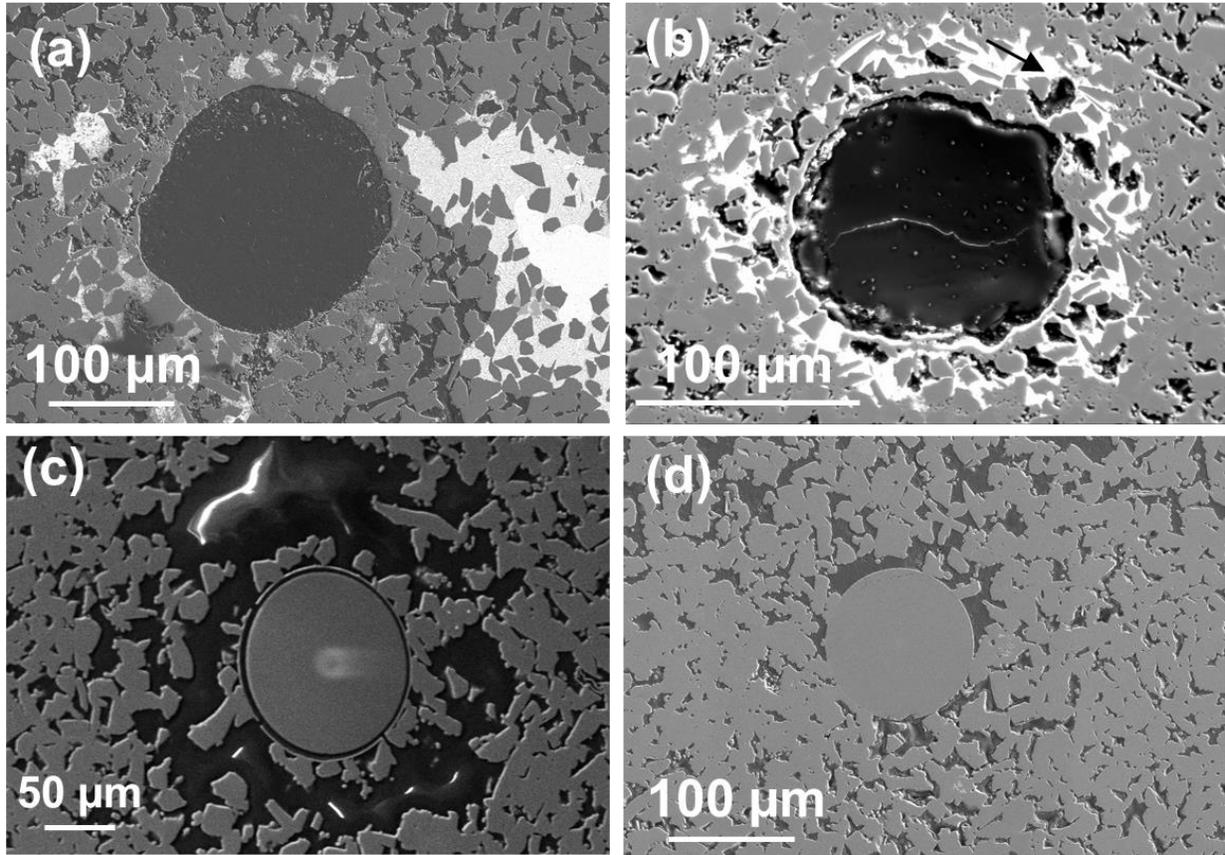
Figure 6. Cross sections showing optical fibers embedded in SiC after CVI with Au (a), Cu (b), and Ormocer (c) coatings, as well as bare fibers (d).

Materials compatibility tests were performed by placing various fiber-optic samples in a SiC can filled with loose SiC powder. This simple test allowed the interfaces between the fiber, fiber coating, and SiC matrix to be examined after embedding. This test was necessary for determining the best candidate fiber coating material to use for future instrumented tests into which functional fiber-optic sensors would be embedded. Figure 6 shows scanning electron microscopy images of the various fiber-optic samples after embedding via CVI and sectioning the cans. Both the Au and Cu metal coatings—shown in Figure 6(a) and Figure 6(b), respectively—show signs of melting, as evidenced by the non-annular shape of the fiber coatings and the SiC powder granules that penetrated into the molten metal during CVI. Melting the coating does not necessarily preclude using these fibers for strain-sensing applications if there is adequate strain coupling between the fiber and surrounding SiC matrix. This also assumes that the sensors will not be subjected to temperatures approaching the melting point of the coating during operation after embedding. Metal coatings could also be used for temperature-sensing applications, but there is some risk that melting the coating during CVI could bond the fiber to its sheath as the molten coating material cools. This would impact the temperature calibration due to the large difference in the thermal expansion coefficient between the fiber and surrounding metals (i.e., the coating and sheath). It is unclear whether the small crack in the Cu-coated fiber occurred during CVI or during polishing. The Ormocer-coated fibers shown in Figure 6(c) show relatively large voids surrounding the fiber. It is suspected that after the Ormocer coating vaporized, large voids were left that were only partially filled during CVI. Because the bare optical fibers shown in Figure 6(d) appeared to be well-embedded without any issues with melting the fiber coating, only bare optical fibers were used to embed functional fiber-optic strain sensors in the experiments described in this report.

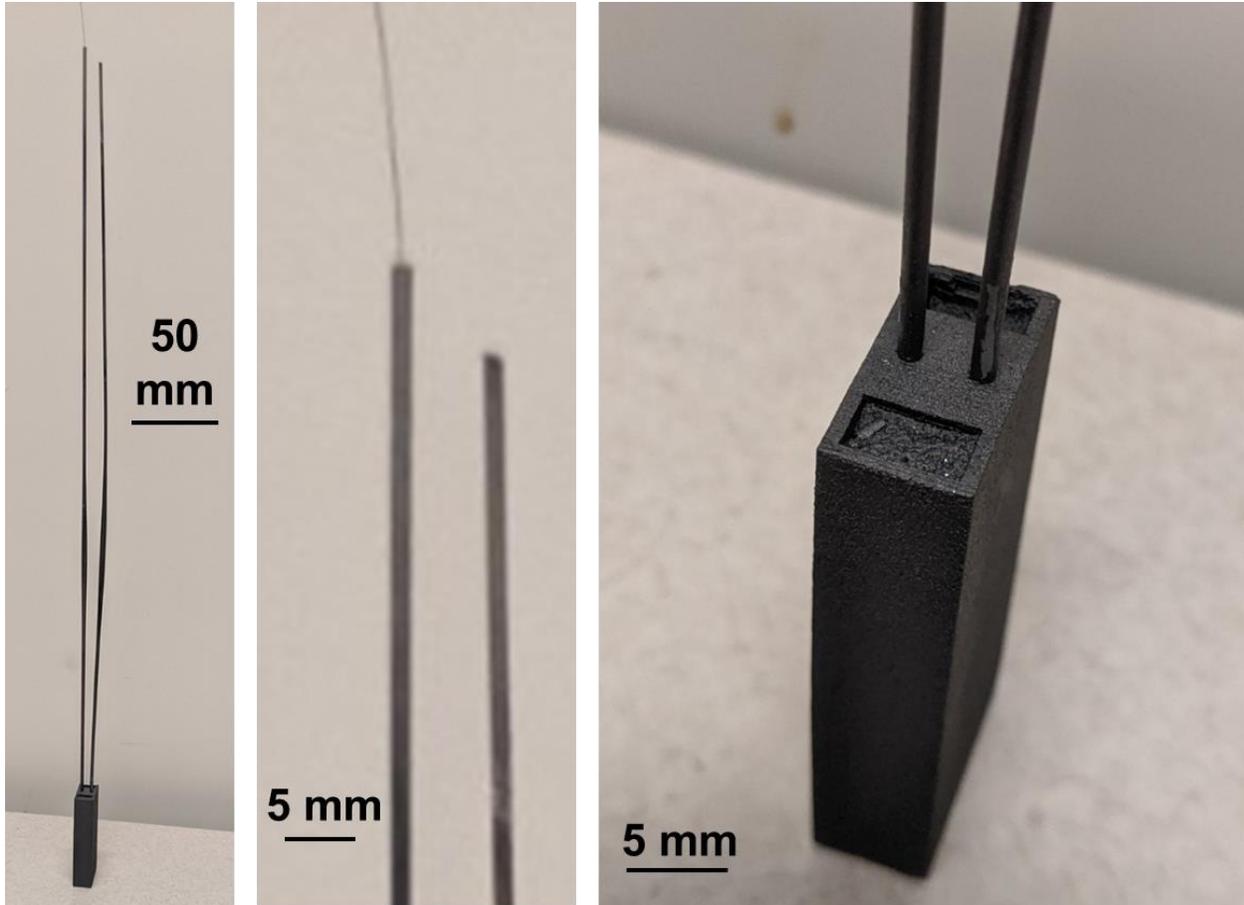
Figure 7. Photographs taken after the uninstrumented experiment showing the 3D printed part with two Mo-sheathed fiber-optic sensors (left); a close-up view showing one of the two optical fibers passing out of its sheath (center); a close-up view showing the sensor sheaths embedded in the part (right).

Photographs taken after the uninstrumented experiment are shown in Figure 7. One of the two fiber-optic sensors is shown exiting its Mo sheath after CVI. The other broke somewhere inside its sheath. Although the two Mo sheaths appear to be well-embedded in the SiC component, one of the two sheaths was only loosely held in place and became disengaged from the part during disassembly.

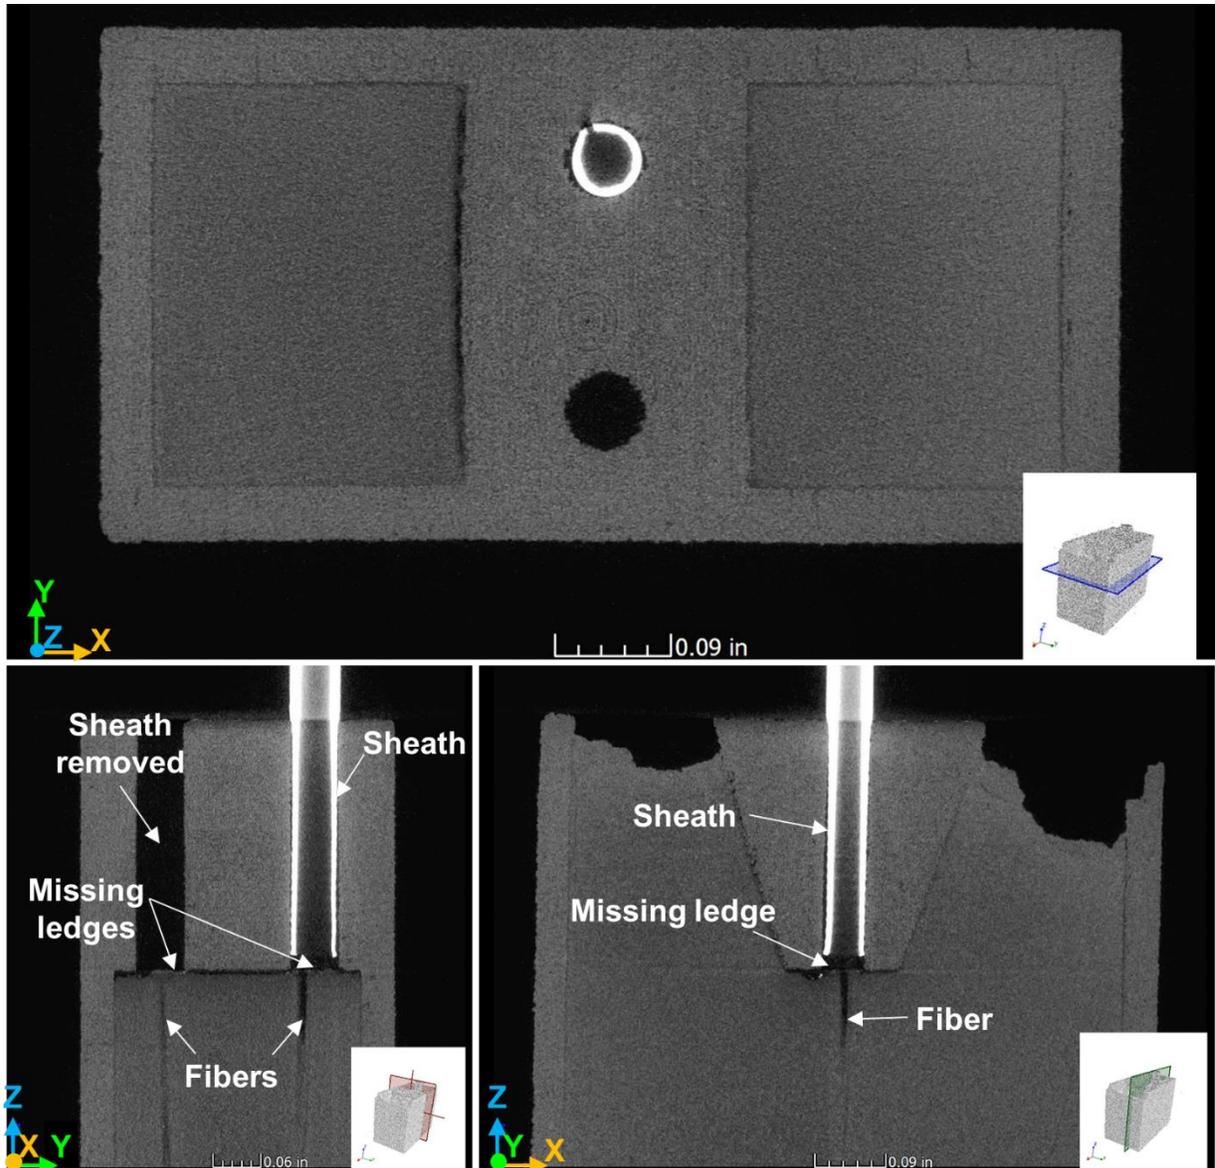
Figure 8. XCT images showing the embedded fibers and fiber sheaths from the uninstrumented test.

X-ray computed tomography (XCT) was performed on this part to gain more insights into the bonding of the sensor sheaths and the fiber-optic sensors. Figure 8 shows images taken from the XCT in three different planes. As mentioned previously, one sheath became disengaged from the part during disassembly. The remaining sheath appears to be embedded in the SiC part, but the top view shows that the sheath split open after CVI. This was likely due to the reduced wall thickness of the sheath within the embedded region and the differential thermal stresses that were generated during constrained heating and cooling. The sheath wall thickness was reduced because the holes in the SiC part were slightly undersized. Additionally, the thin ledges upon which the sensor sheaths were supposed to rest (Figure 3) are no longer present in the XCT images. These ledges were likely too thin and broke either during assembly or during CVI.

The low densities of the fused silica optical fibers make the fibers difficult to distinguish from voids in the XCT images. However, because previous material compatibility tests showed that the fibers survive the CVI process, as shown in Section 3.1 and previous work [4], the fibers are likely located in the regions indicated in Figure 8. Figure 8 shows that at least one of the two fibers was misaligned inside its sheath. The ledge that was originally designed to support the sensor sheath also had a smaller diameter through-hole that was designed to keep the fibers concentric with the sheath. When the ledges broke, that alignment could no longer be guaranteed. The combination of the fragile nature of the bare optical fibers, poor alignment without the ledges in the SiC part, and potential sudden movement of the sheath once the ledge was broken likely explain why the fibers broke inside the SiC part.

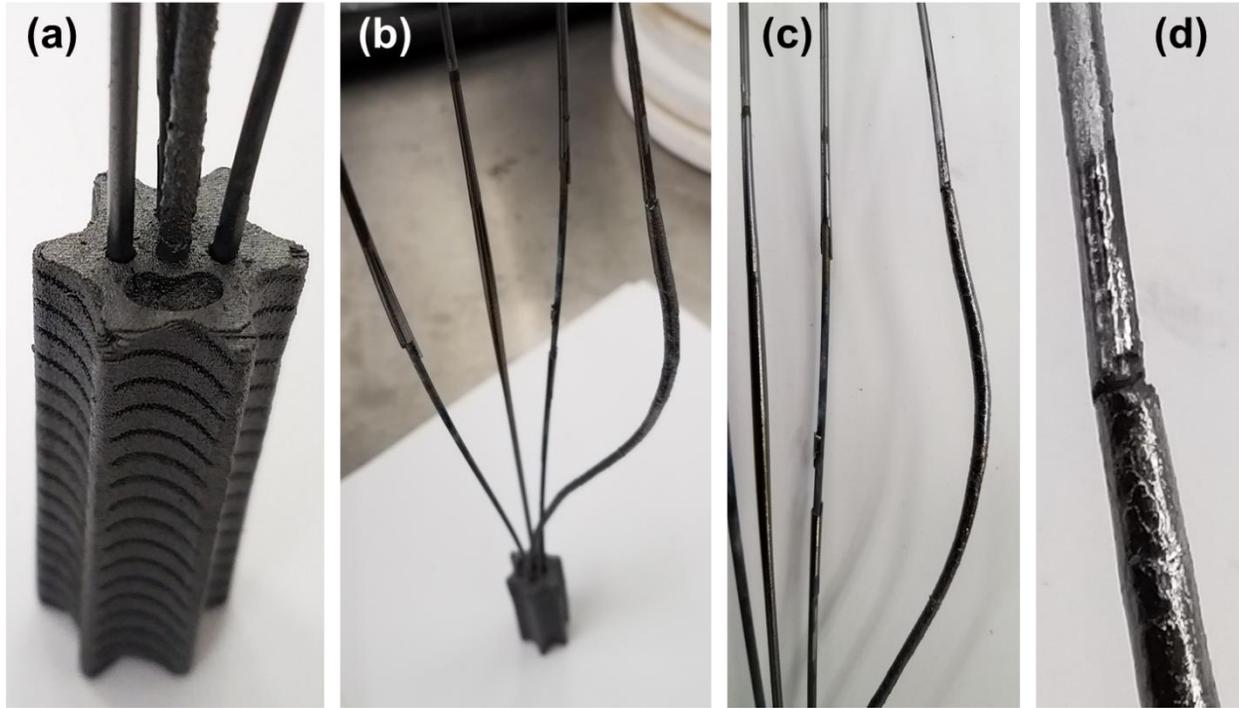
Figure 9. Post-CVI photographs from the instrumented experiment showing the 3D printed SiC component with embedded sensors (a), a top-down view showing the sensor leads (b), a side view of the sensor leads (c), and a close-up view of the HTIR TC lead where it cracked (d).

Figure 9 shows photographs of the SiC component with embedded sensors after the instrumented experiment was completed. All four sensor leads appeared to be well-embedded in the SiC component. Unfortunately, the Nb-sheathed HTIR TC suffered from severe bowing. This was unexpected based on previous thermodynamic analyses and materials compatibility tests performed on Nb [4]. As described in Section 2.2.2, the sensor leads were constrained from expanding at the top of the experiment by using compression fittings and at the bottom by the part itself and the graphite spacer on which the part was placed. Thermal expansion might cause some bowing (a few millimeters over a ~46 cm length) of the sensor leads, but this was not expected to be a significant issue, as evidenced by the reasonable amount of bowing in the Mo sheaths. At ~1,000°C, the thermal expansion coefficient of Nb (8 μm/m/K) is only slightly greater than that of Mo (5.7 μm/m/K). Therefore, it is unlikely that thermal expansion could account for the large difference in bowing between the Nb and Mo sheaths. The Nb sheath was heat treated at temperatures of 1,450°C or higher before CVI operation [26]. Therefore, although it is unlikely that the large observed bowing was caused by significant grain growth at the lower CVI temperatures, the heat treatment also makes the sheath more brittle, which could have contributed to the cracking that was observed post-CVI.

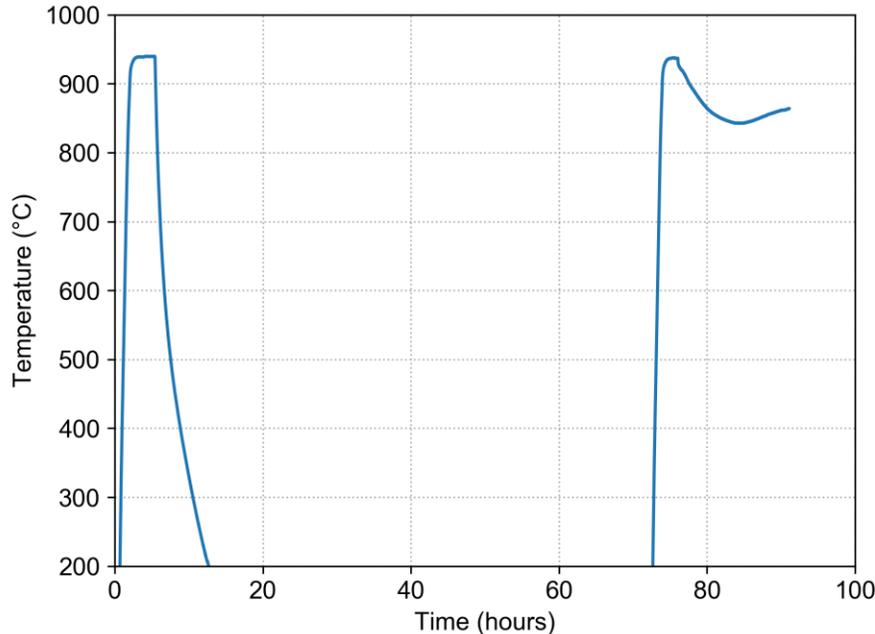
Figure 10. Temperature measured by the HTIR TC during heating to 1,000°C in Ar (0–5 hours), cooling to room temperature (6–72 hours), returning to 1,000°C in Ar (72–76 hours), and holding at 1,000°C while flowing MTS and H₂ (>76 hours). The HTIR TC failed at ~91 hours.

Figure 10 shows temperatures measured by the HTIR TC during the first days of operation in the CVI furnace. As mentioned previously, the first ramp to temperature occurred in Ar, and the furnace was shut off due to inadequate ventilation before starting MTS and H₂ gas flow. Even in Ar, the HTIR TC recorded temperatures of ~930°C, which was significantly below the 1,000°C set point of the temperature controller. Emails were sent to the HTIR TC manufacturer to verify that the calibration information sent with the HTIR TC was correct. After ramping back to 1,000°C, MTS and H₂ flow was initiated near 76 hours, at which point the HTIR TC reading immediately dropped. The HTIR TC continued to drift over the course of 15 hours until failure occurred near 91 hours. Future work will investigate why the HTIR TC suffered prohibitive expansion, bowing, and signal drift during CVI, particularly after MTS flow was initiated. Based on Nb-H phase diagrams [27], it is likely that the H₂ carrier gas resulted in some formation of hydrides in the Nb sheath, particularly at lower temperatures near the top of the quartz tube. This would cause significant volumetric expansion [28-30], which could explain the observed bowing. Regardless, Mo sheaths appear to perform much better than Nb sheaths. Because Mo-sheathed thermocouples are commercially available, the current focus is on using Mo sheaths for future embedding in SiC components.

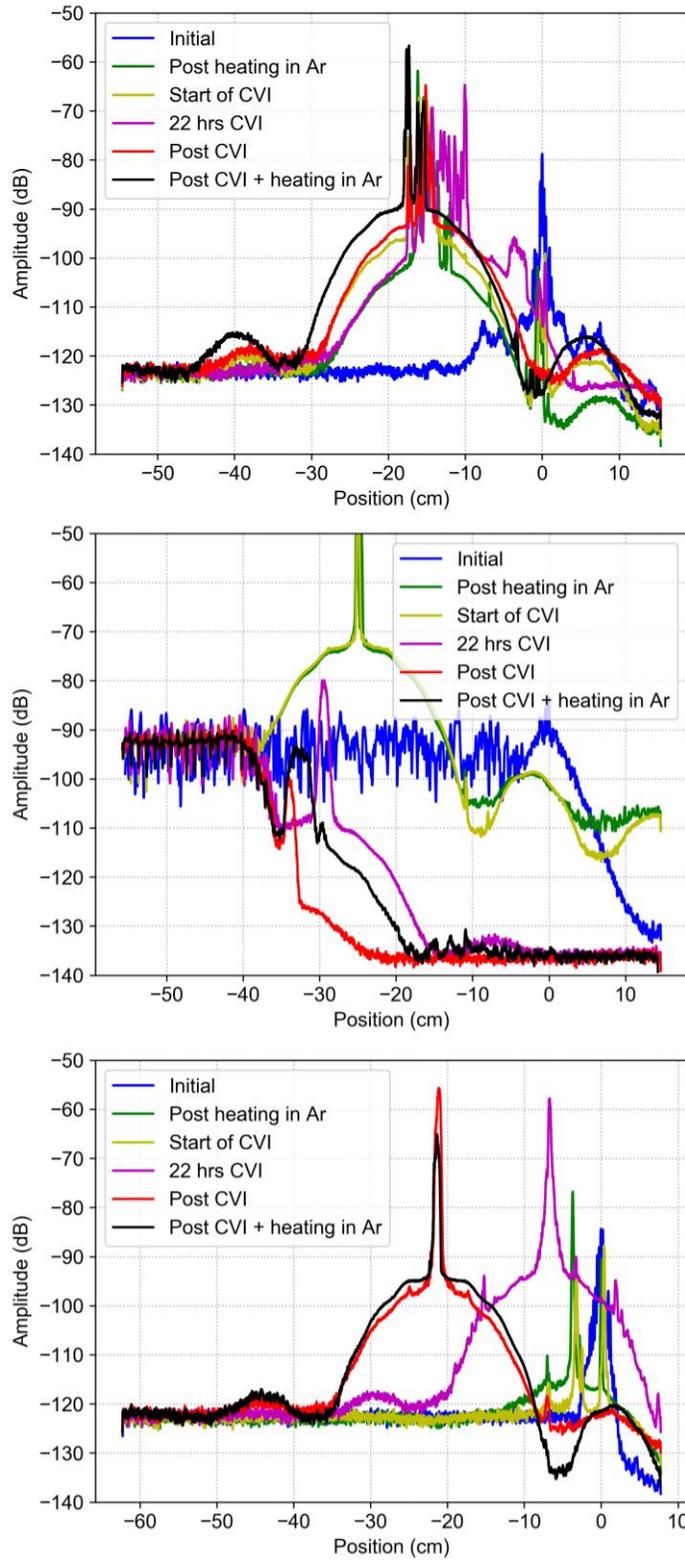
Figure 11. Measured reflected light intensity vs. position at various times during the instrumented CVI experiment. Results are shown for fibers 1 (top), 2 (middle), and 3 (bottom).

All three fiber-optic sensors broke at multiple locations over the course of the instrumented CVI experiment. Figure 11 shows plots of the reflected signal intensity as a function of position along the fiber relative to the end of the fiber at various times throughout the experiment. The large peaks in these plots are caused by light reflections that result from the large difference in the refractive index between the fiber and surrounding gas (Ar or MTS + H₂). Figure 11 shows that fiber 1, a standard singlemode fiber contained inside a closed-ended Mo sheath, broke ~15 cm from initial fiber termination after heating to 1,000°C in Ar. The fiber appeared to break a second time a few centimeters further from the initial termination at the start of CVI. Fiber 2 was directly surrounded by SiC powder, and it also contained Bragg gratings to increase the intensity of light reflections along the fiber's length. This fiber also broke ~25 cm from its termination after heating to 1,000°C. The fiber broke several more times during the CVI. Fiber 3 was a singlemode fiber like fiber 1, except it was surrounded by SiC powder like fiber 2 was. The fiber broke ~4 cm from its termination near the top of the SiC component after heating in Ar. Additional breaks occurred further from the fiber's termination during CVI.

The fibers were stripped of their coating within the embedded region before assembly in an effort to improve strain coupling (Section 3.1). However, the results of the instrumented experiment show that the bare fibers are too fragile and are susceptible to breaking, even with a protective Mo sheath. The thermal expansion of the constrained sheaths also causes some sheath bending, which could be enough to break the fragile, uncoated fibers. Future experiments will use metal coatings, which should prevent fibers from breaking if the coatings do not melt. However, custom metal coatings might be necessary, considering that commercially available Au and Cu coatings might melt at the process temperatures.
